Navajo Abandoned Uranium Mine

Site Screen Report

NA-0410 AUM Site

March 2010

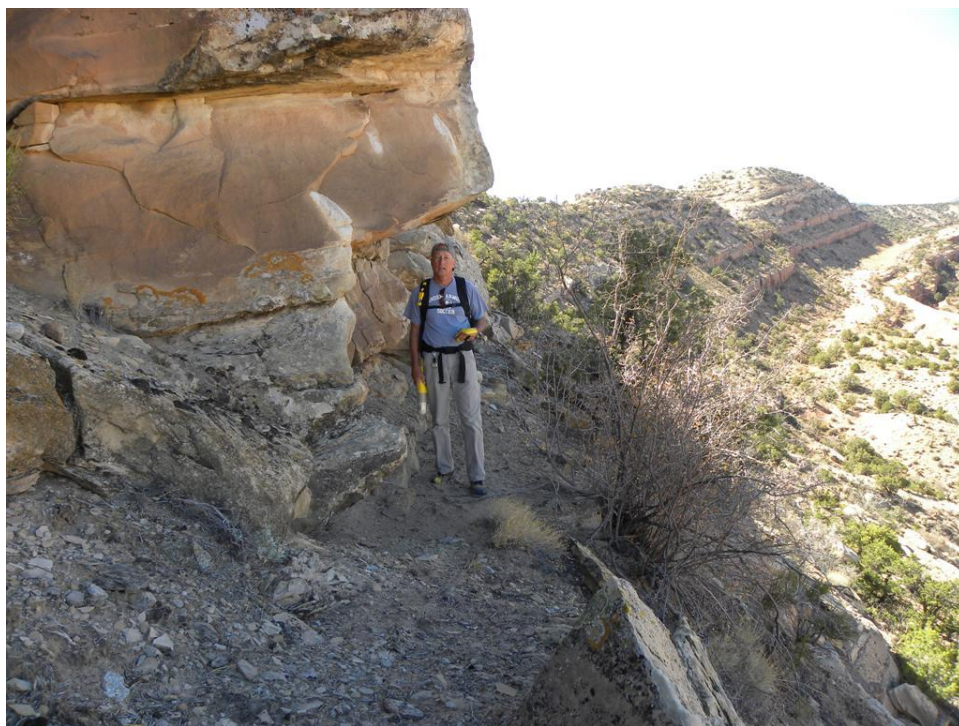
Photo 4. Mine site cliff overhang
